Appendix C3 – Source Identification (Stormwater Management)

BMP Geodatabase – DRAFT Schema 17 December 2018

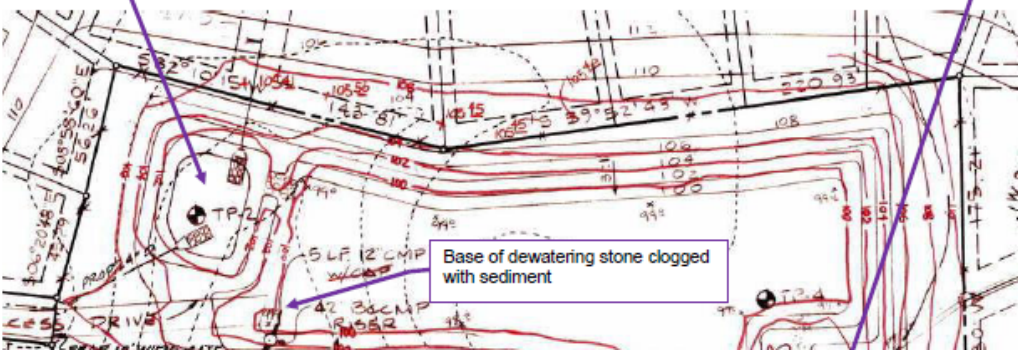
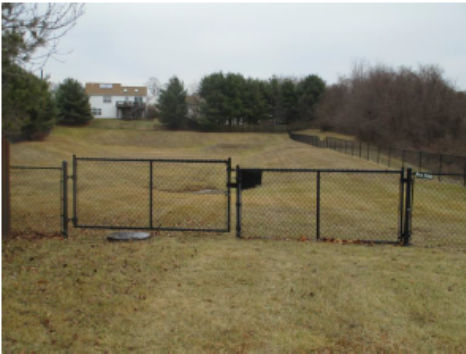
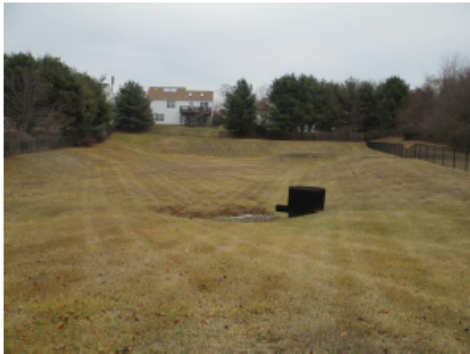
Figure 5: Completed Inspection Form

STORM WATER MANAGEMENT INSPECTION REPORT			
Project:	Magnolia Farms		
Site Address:	0 MAGNOLIA RIDGE DR		
Site Location:	Magnolia Ridge		
Description:	Magnolia Farms stormwater management facility		
Owner Name:	MAGNOLIA FARMS HOMEOWNERS ASSOCIATION INC	Owner Address:	810 WOODMONT CT, JOPPA, MD 21085
Management Company	Address:		
Facility Type: EDSD			
<u>Comments/Corrections</u>			
<div style="border: 1px solid black; padding: 5px; margin-bottom: 10px;"> Forebay: <ul style="list-style-type: none"> The storm drain closest to the gate has a sediment load; approximate dimension 20'x15'x1' The storm drain farthest from the gate has a sediment load; approximate dimension 20'x15'x1.5' The spillway is severely eroded. There is significant sediment deposition at the base of the spillway from the eroded weir. </div> <div style="border: 1px solid black; padding: 5px;"> Forebay: <ul style="list-style-type: none"> The entire bay is full of sediment accumulation; approximate dimension is 30'x20'x2' The spillway is channeling flow; stone is displaced. </div>

<p>Restore both forebays to plan specifications. Remove vegetation from the fence. Remove rocks from barrel's end section. Rake the base of the dewatering stone to loosen sediment accumulation. Monitor dam over the pipe for settlement.</p> <p>It is requested that the described actions be performed within thirty days of this notification so as to bring this facility in compliance with Harford County's Stormwater Management regulations. Please contact our office at 410-638-3545, ext. 2435, or email at cjoyce@harfordcountymd.gov if there should be any questions and to schedule a re-inspection once the work has been completed.</p>			
Inspection Date: 01/29/2018		Re-inspection Date: 06/04/2018	
Inspected: Christy Joyce		Emailed: Site Rating: 2	
		Date: 3/10/2018

Gate in alignment		View of pond

The Bureau of Stormwater Management removes the body of the inspection form and leaves just the Comment/Correction field and the Site Rating at the bottom (see Figure 4) when submitting a pdf of the inspection to the owner. Harford County Codes require inspectors to inform the owner what remediation is required. Inspectors generate very detailed conclusion/correction recommendations to meet this requirement. Inspectors include detailed written recommendations and photographs identifying the corrective action required for the BMPs to be in compliance. The inspector may also include marked-up As-Built and photographs from the inspection to assist the owner in knowing which BMP is being referred to (see Figure 5). The inspection report is then converted into a pdf and emailed to the owner.

An example of a completed inspection form is shown in Figure 5.
